# Vessel Mooring Study - Boca Chica Harbor - Monroe County, Florida

## Final Project Report

May 17, 2011

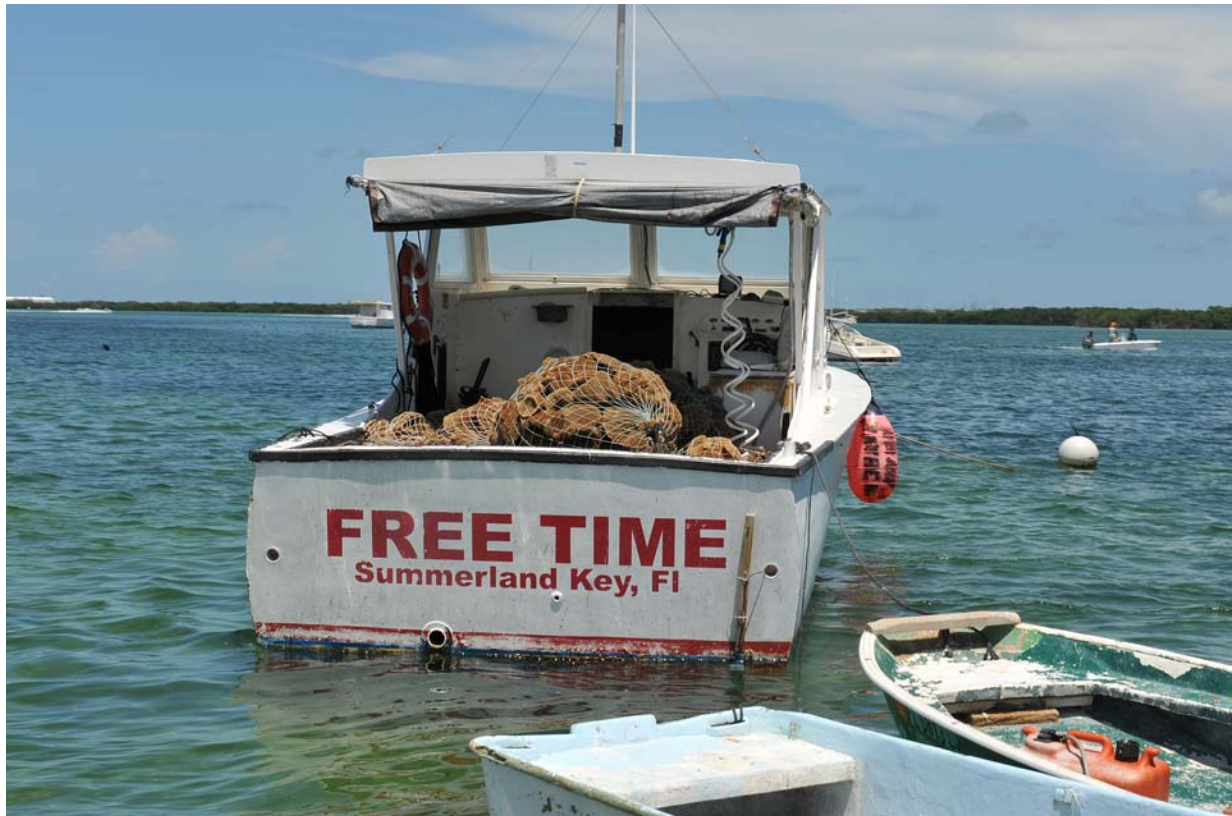
Photo of a stored powerboat being used in support of commercial sponge fishing.

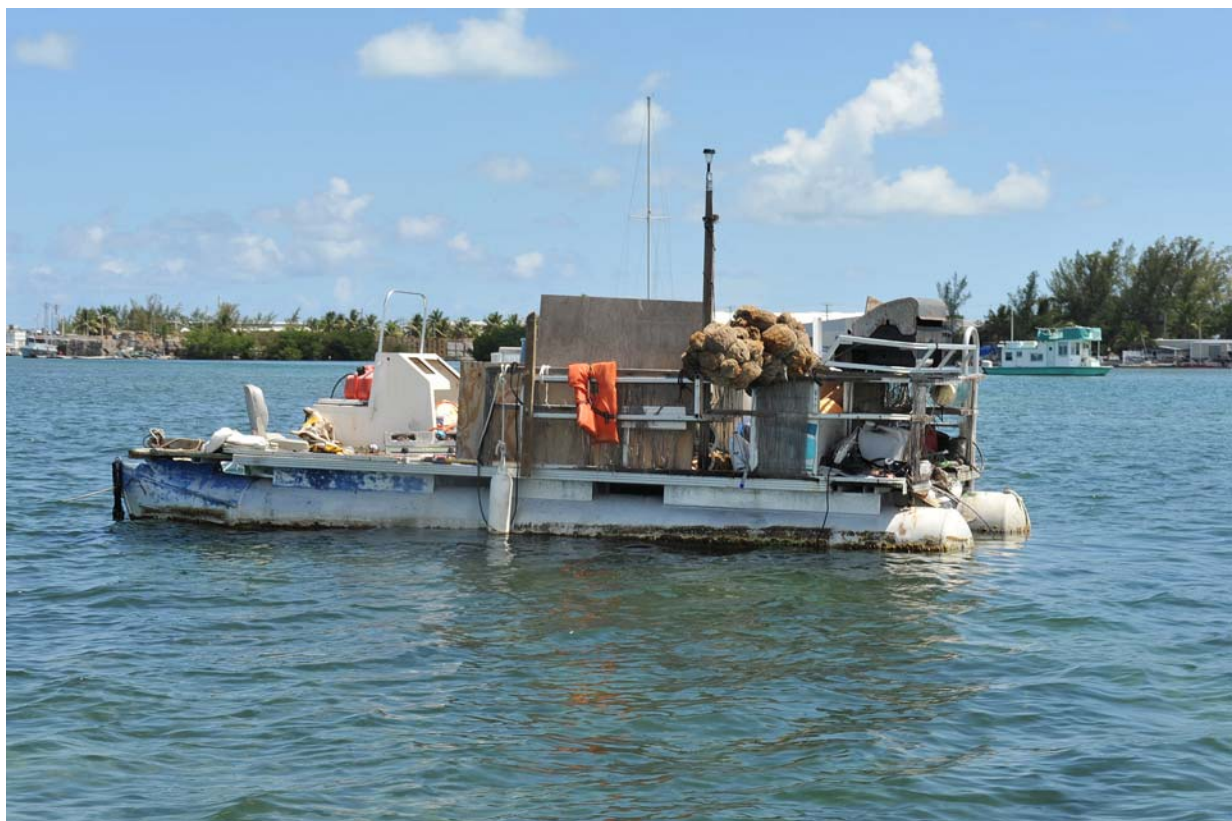
Photo of a stored powerboat being used in to store personal property.

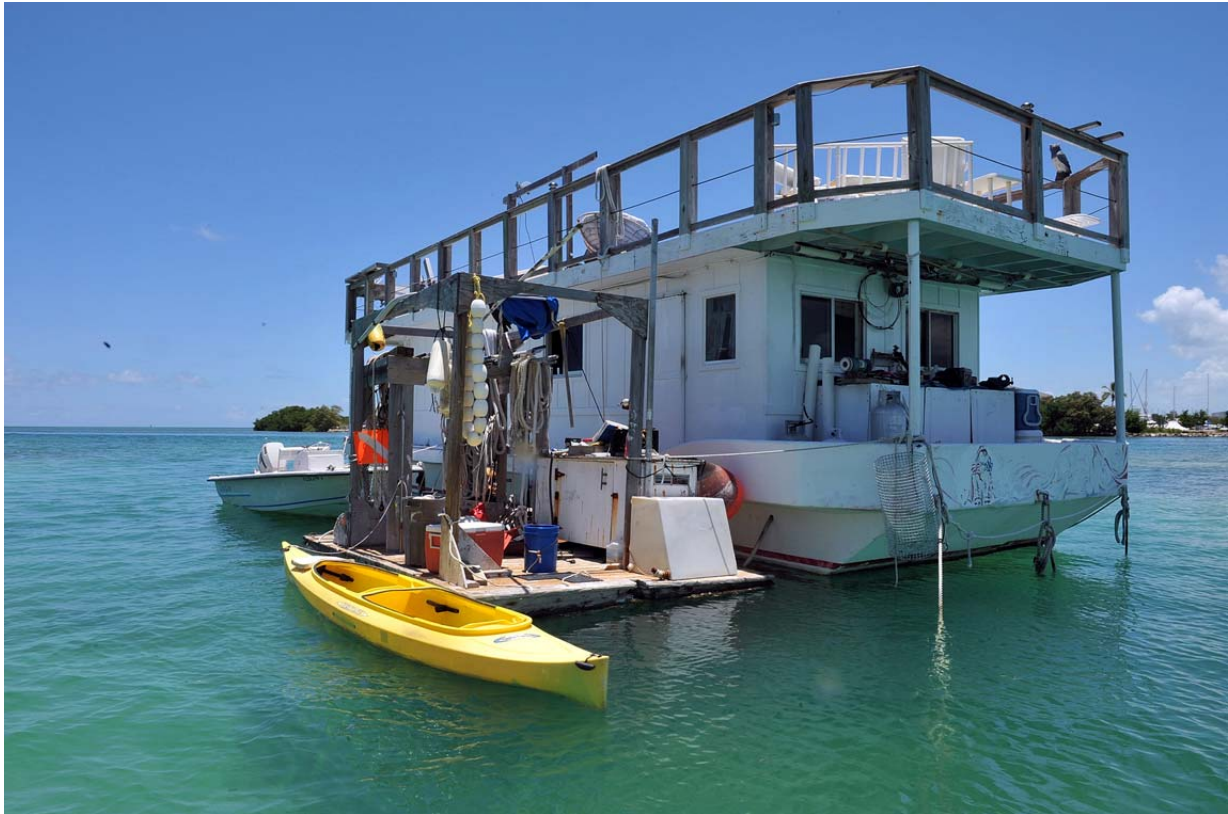
Photo of a typical well-maintained houseboat. The floating platform is moored to the houseboat and functions as an outbuilding that provides storage for personal property.

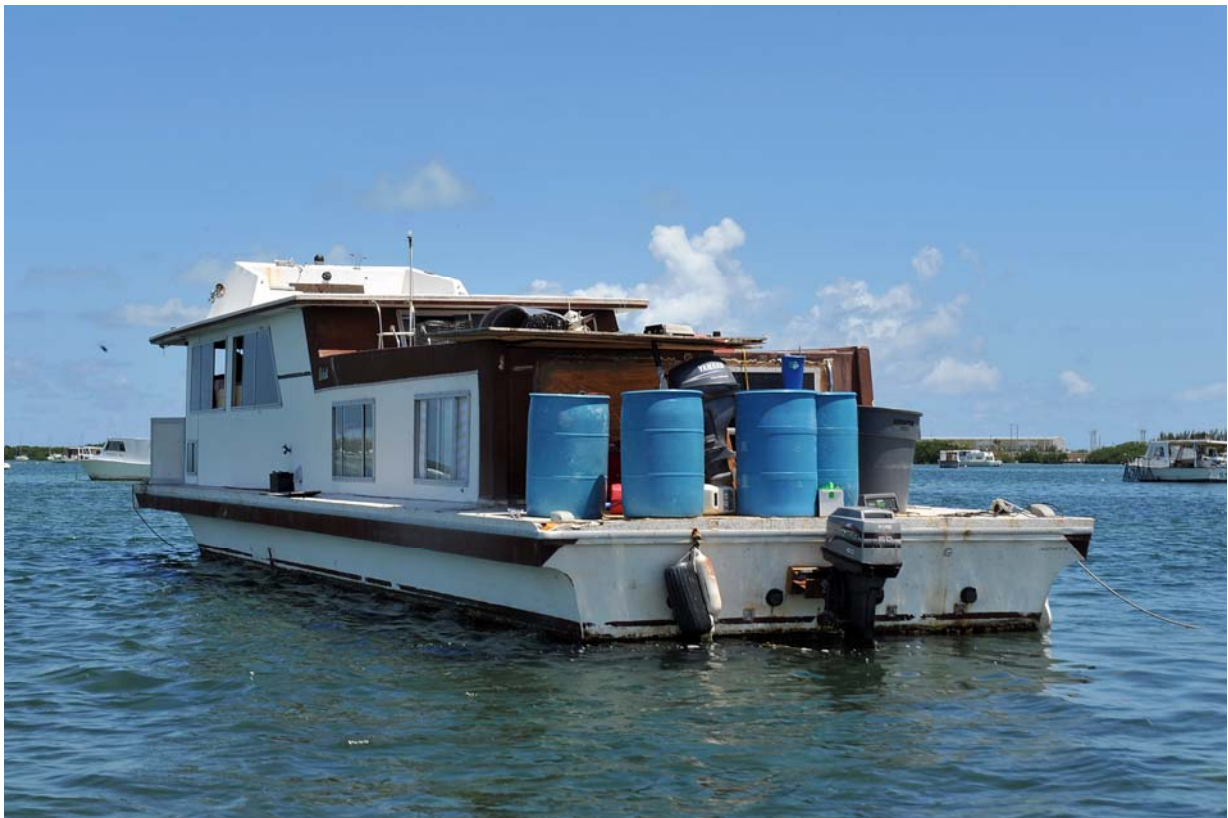
Photo of a typical well-maintained houseboat.

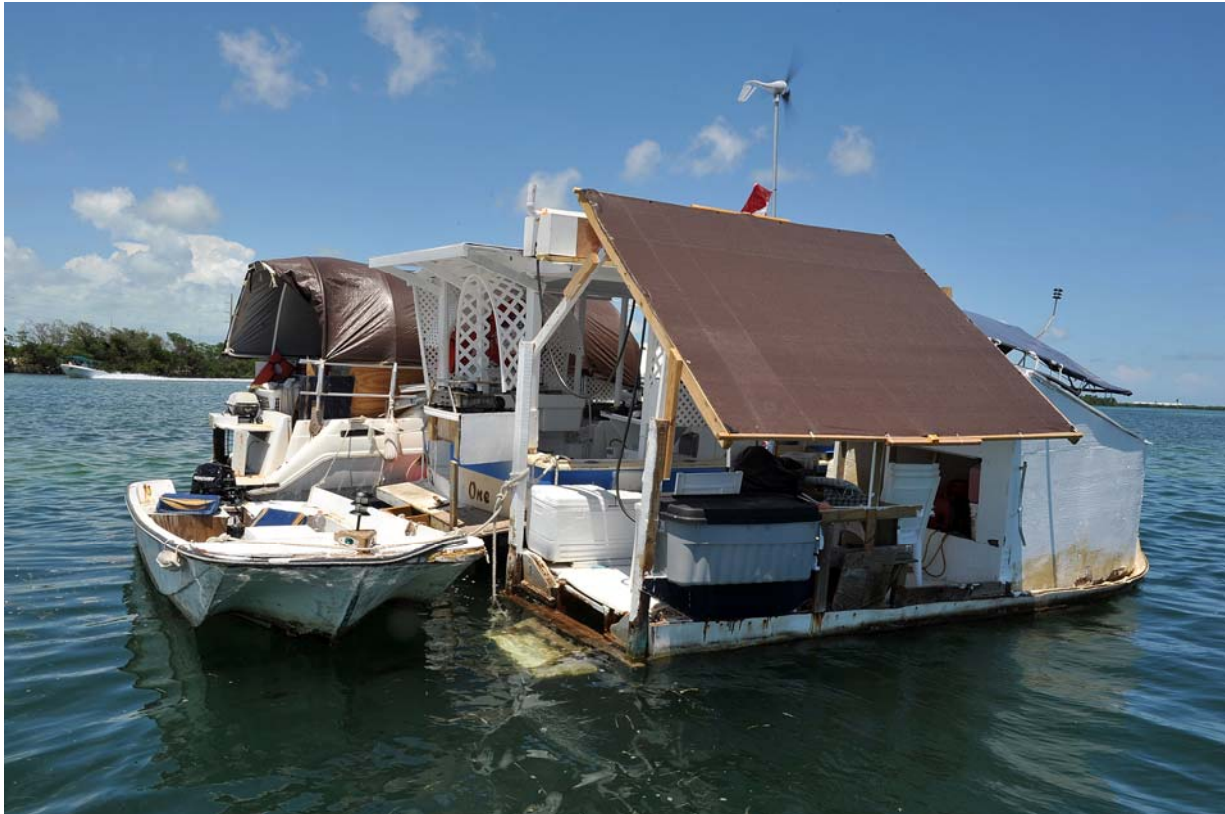
Photo of a conglomeration of vessels that form a liveaboard complex. This complex is consists of Several powerboats and floating platforms.

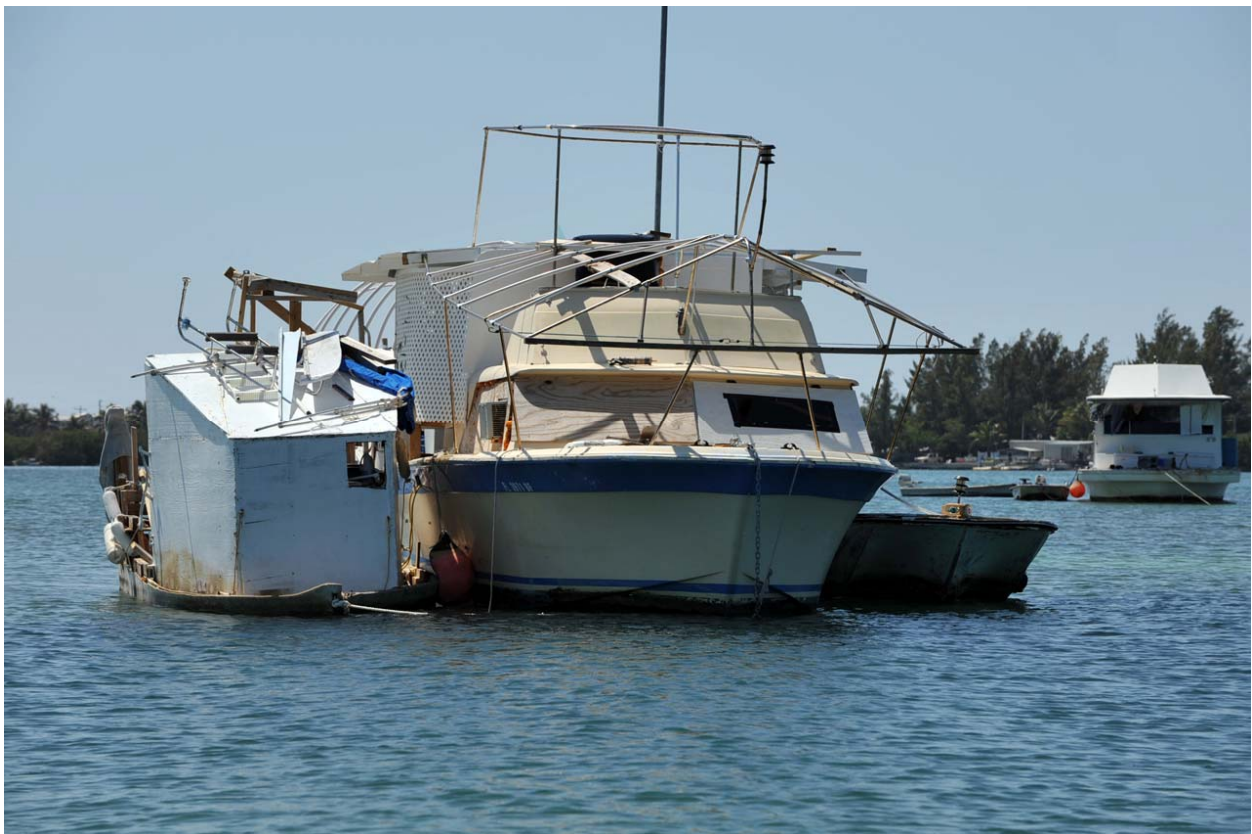
Photo of a conglomeration of vessels (same as above) that form a liveaboard complex. This complex is referred to as Water World in the mooring database and consists of powerboats and floating platforms.

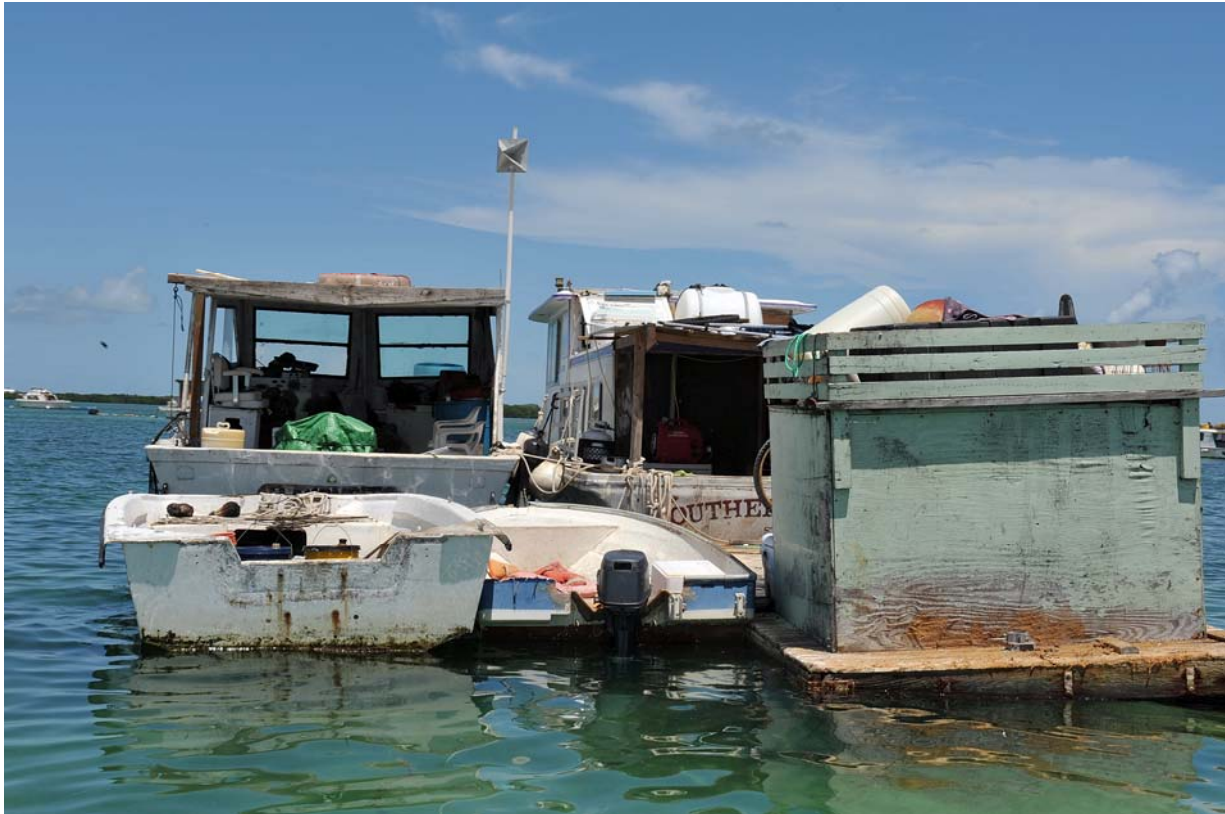
Photo of a conglomeration of vessels that form a liveaboard complex composed of several powerboats and floating platforms.

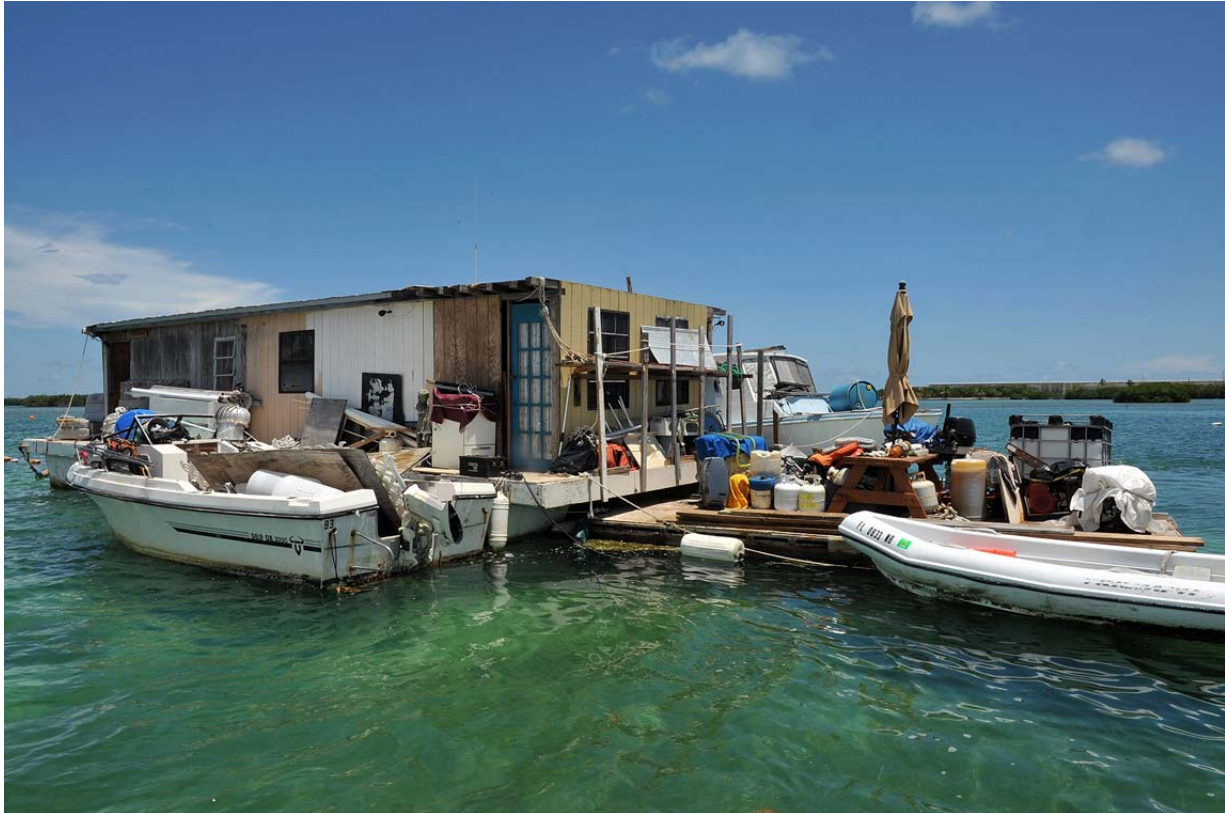
Photo of a conglomeration of vessels that form a liveaboard complex composed of several powerboats and floating platforms.

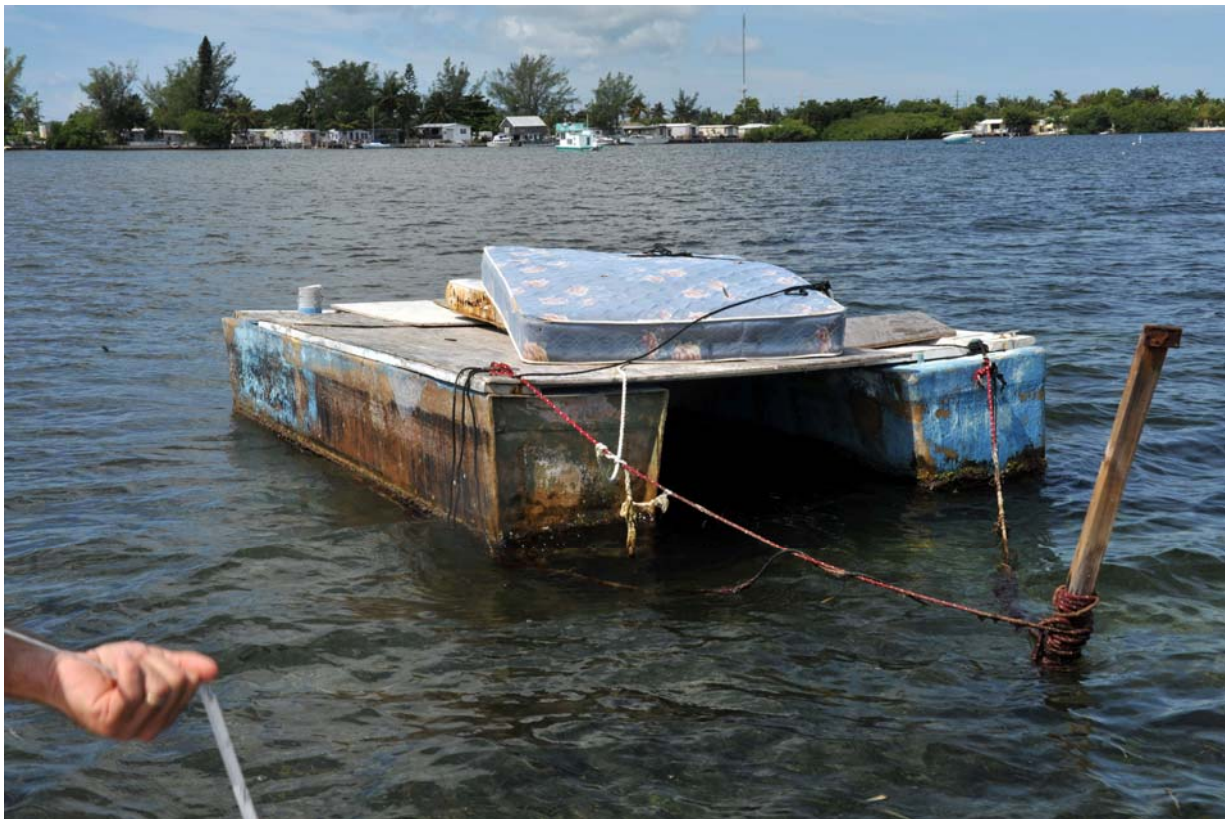
Photo of a floating platform being used for storage. This platform stored a mattress throughout the entire survey period.

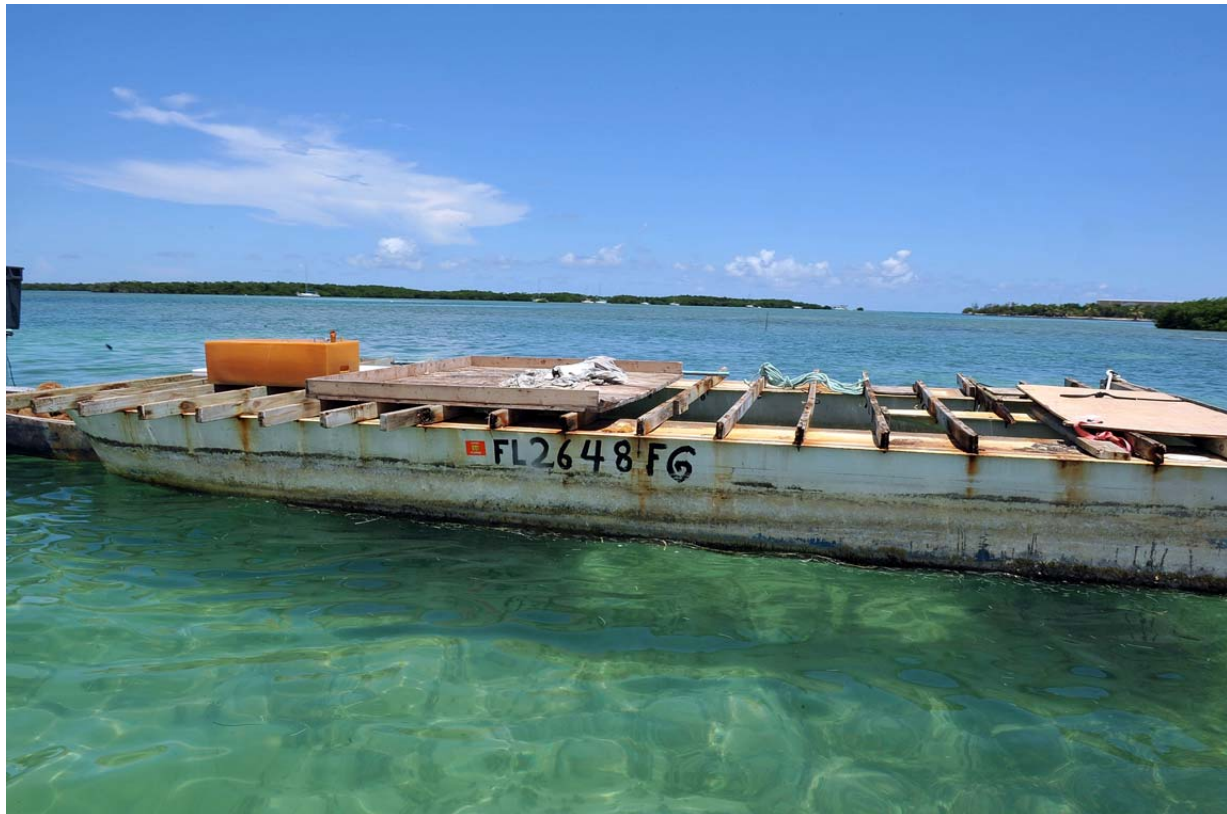
Photo of a floating platform being constructed.
